Final
Cultural Landscape Report
Volume 1

Pahaquarry Copper Mine
DELAWARE WATER GAP

August 1995

by
Steve R. Burns Chavez
A. Berle Clemensen

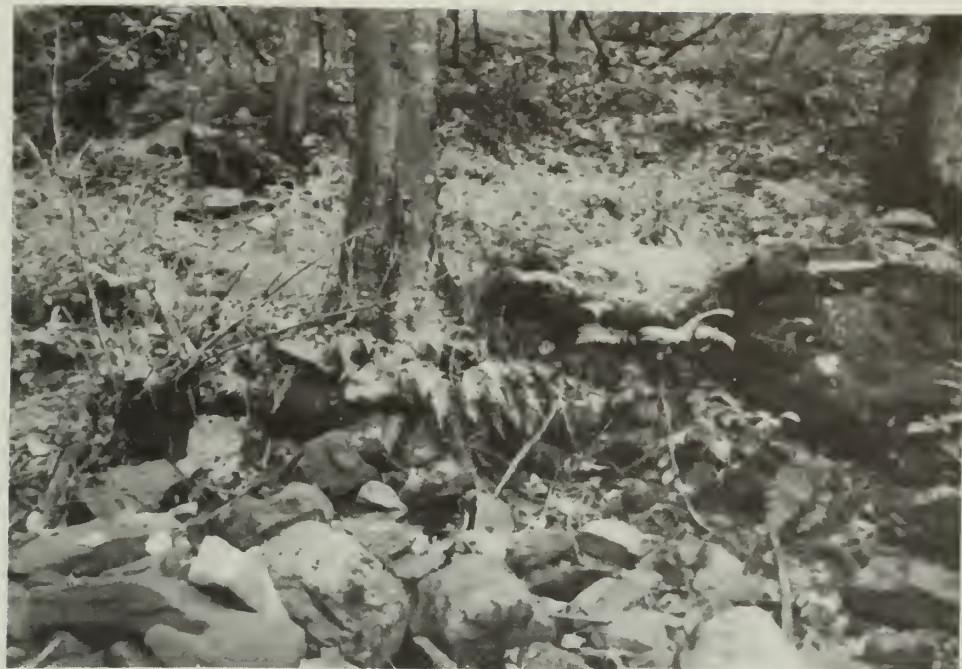
Figure 6A Photo 44
1750s period probable tail race alignment form lower dam

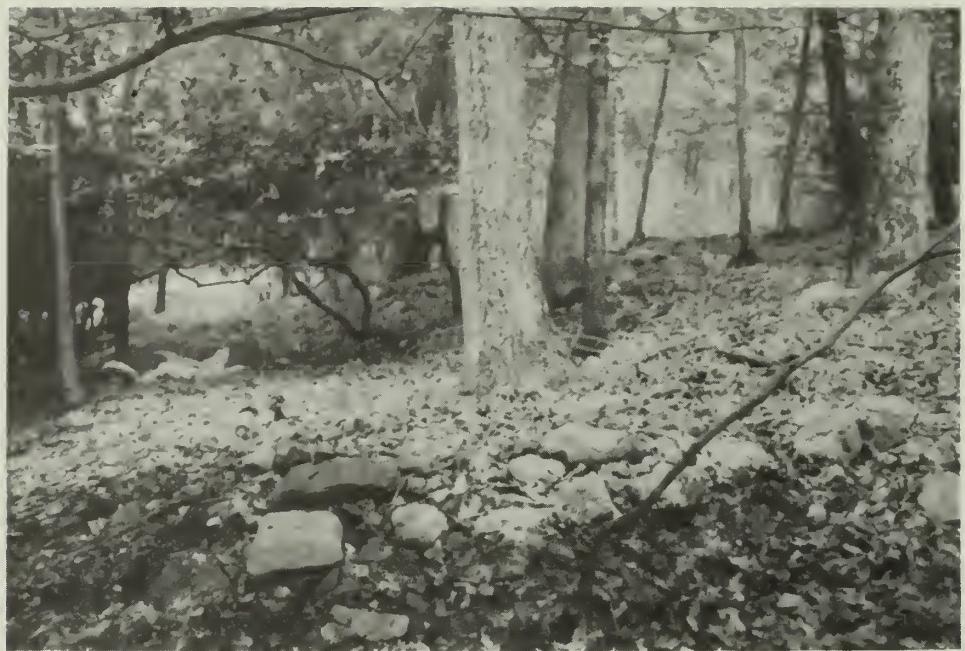
Figure 6A Photo 45
1750s period lower dam where cut through by mine brook

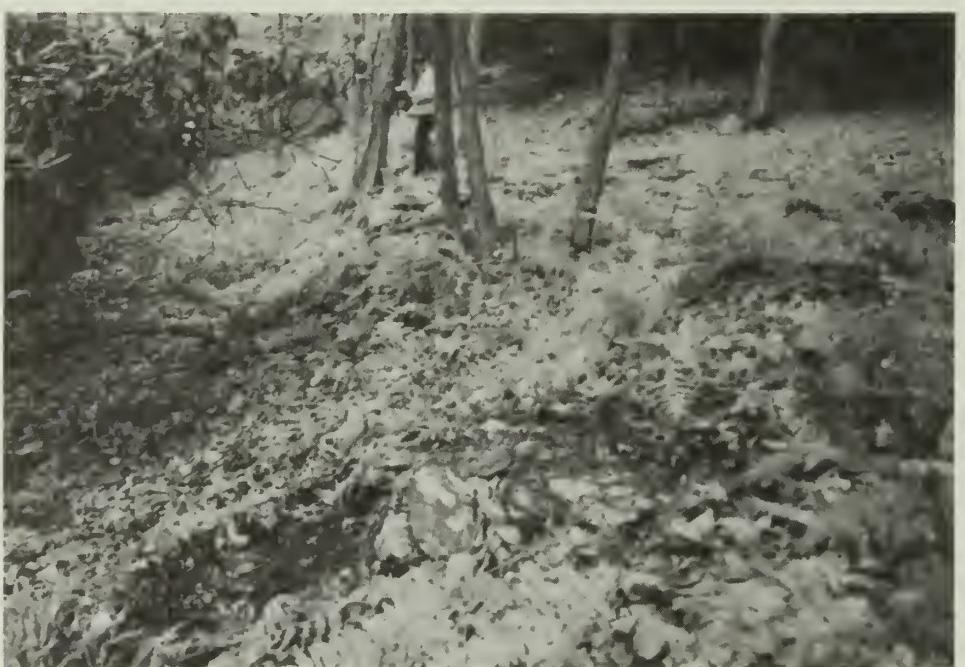
Figure 6B Photo 1
1908 possible beginning of elevated section of train

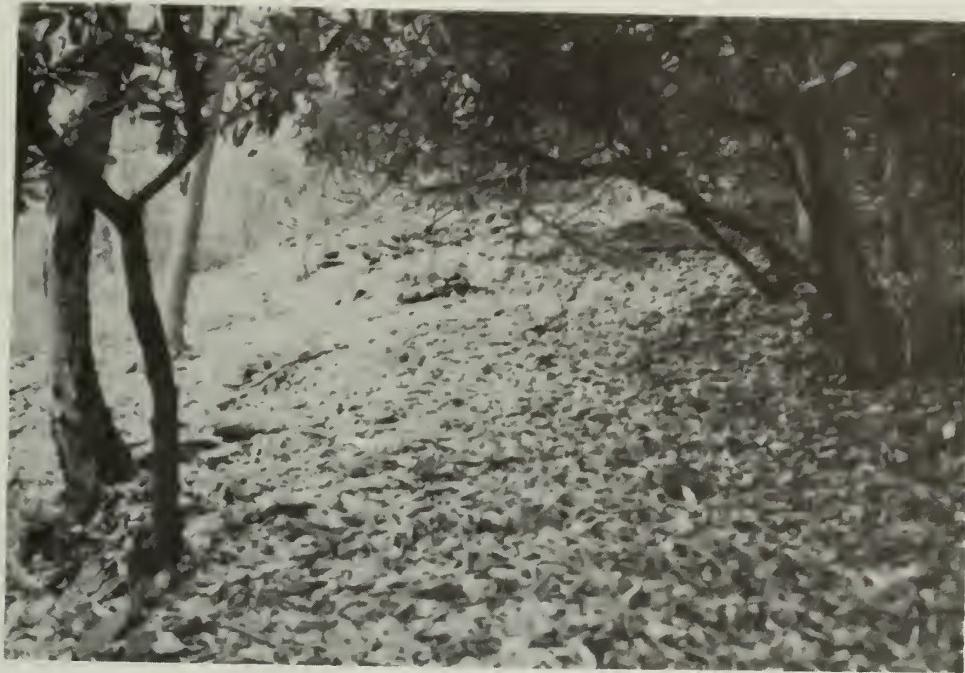
Figure 6B Photo 2
1908 tramway footings of dry laid stone piles 10 feet apart

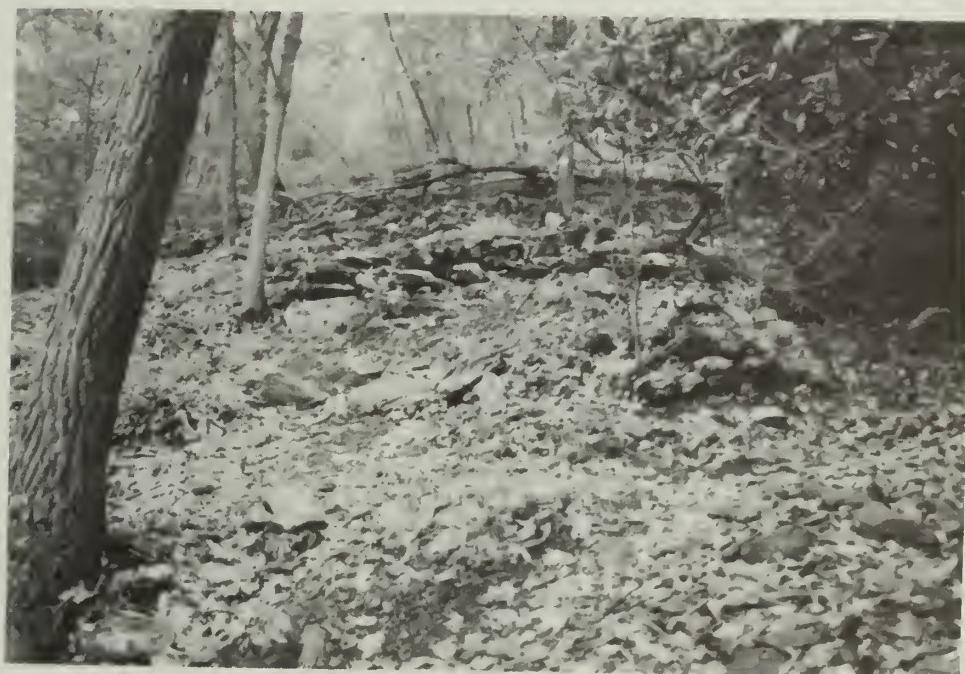
Figure 6B Photo 3
1908 tramway trace with stone track footings

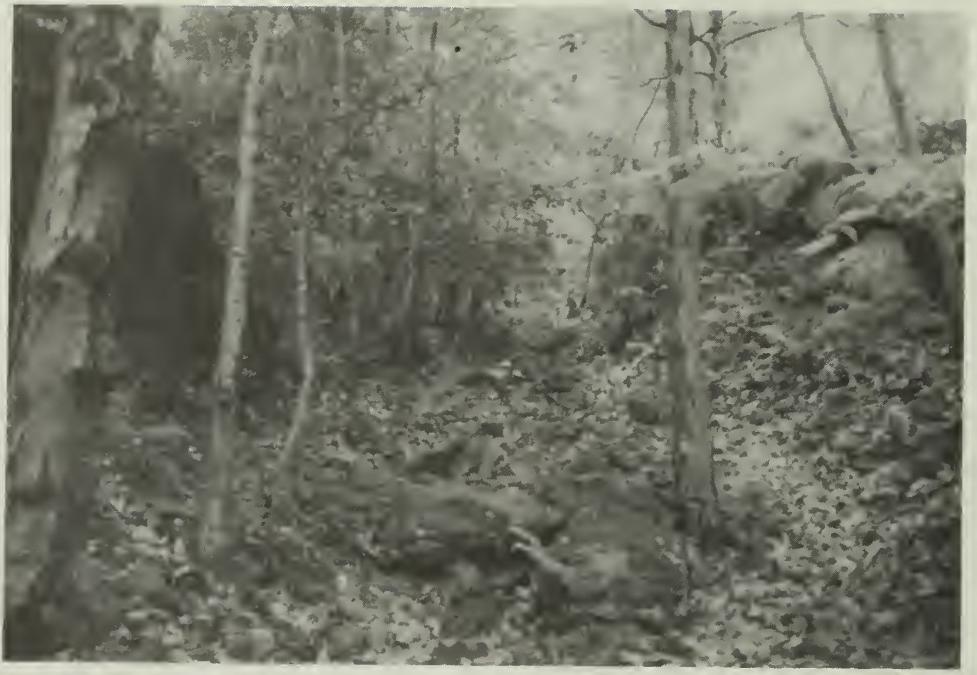
Figure 6B Photo 4
1908 tramway trace with stone track footings

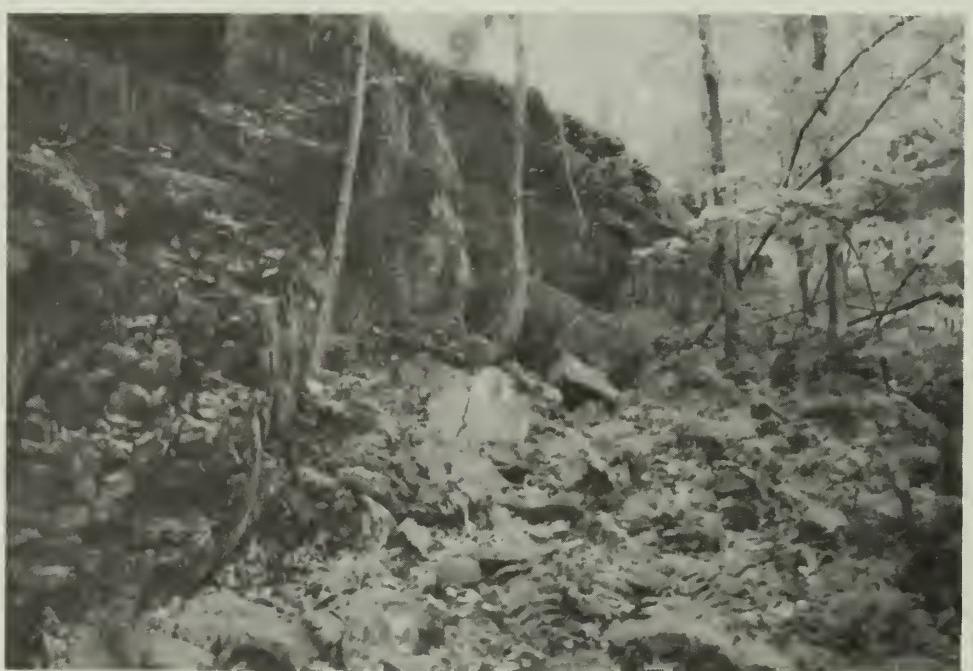
Figure 6B Photo 5
1908 tramway "cut"

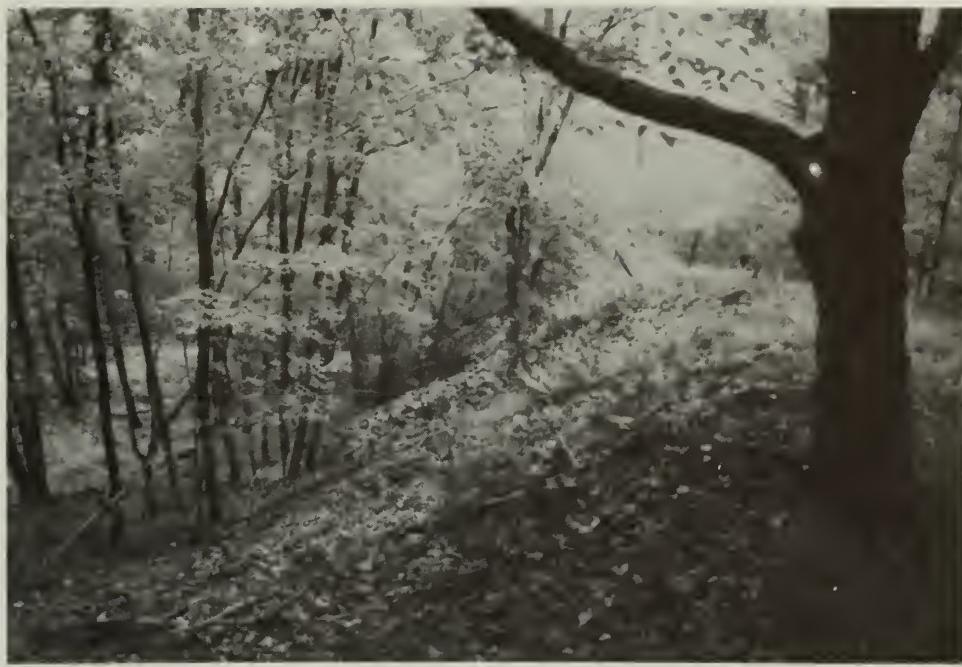
Figure 6B Photo 6
1908 tramway "cut"

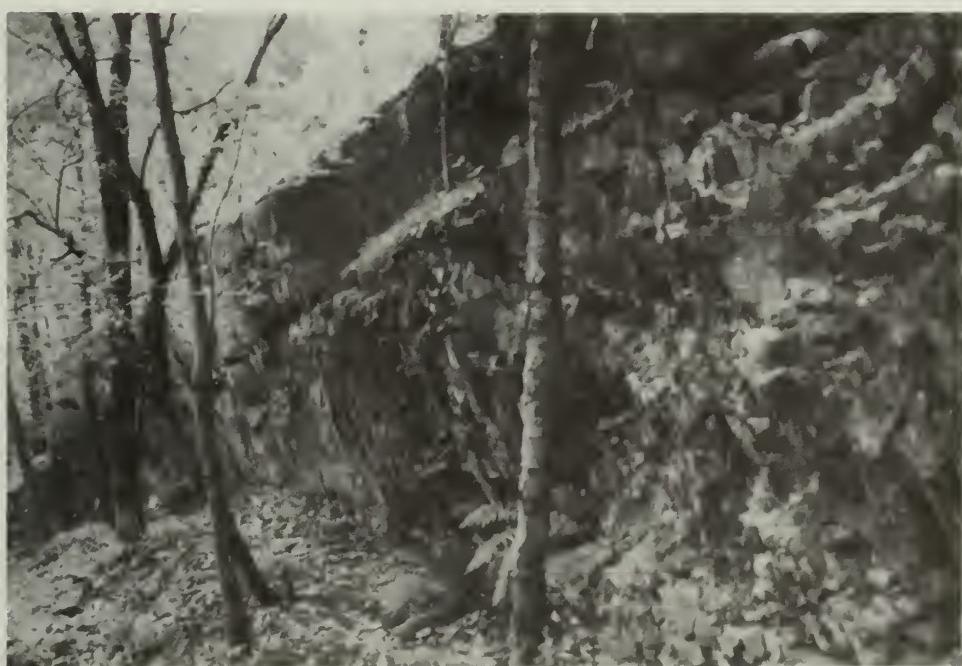
Figure 6B Photo 7
1908 spoil pile from tramway cut

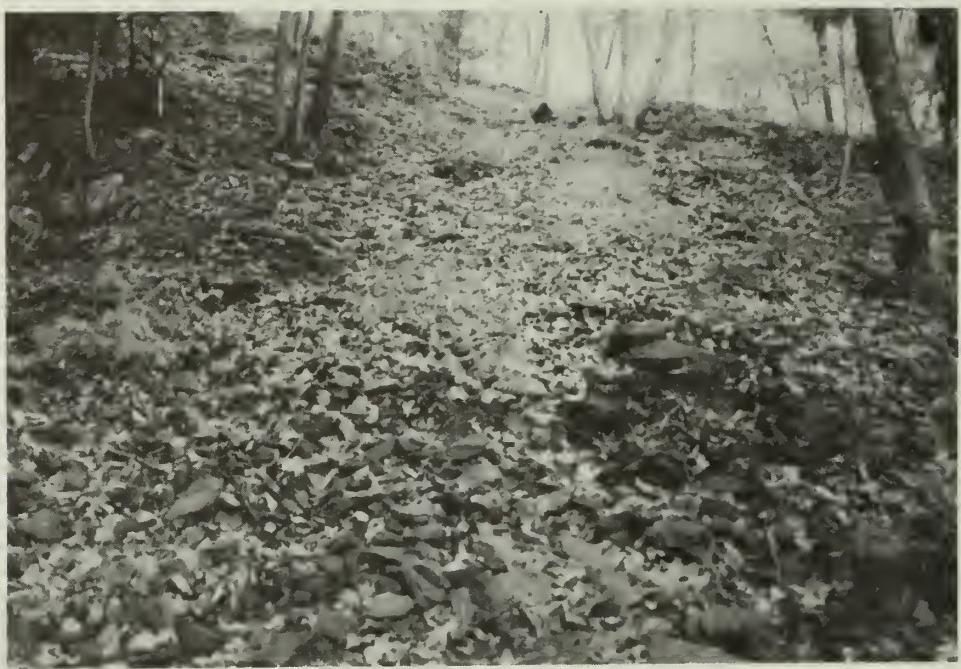
Figure 6B Photo 8
1908 tramway "cut" wall

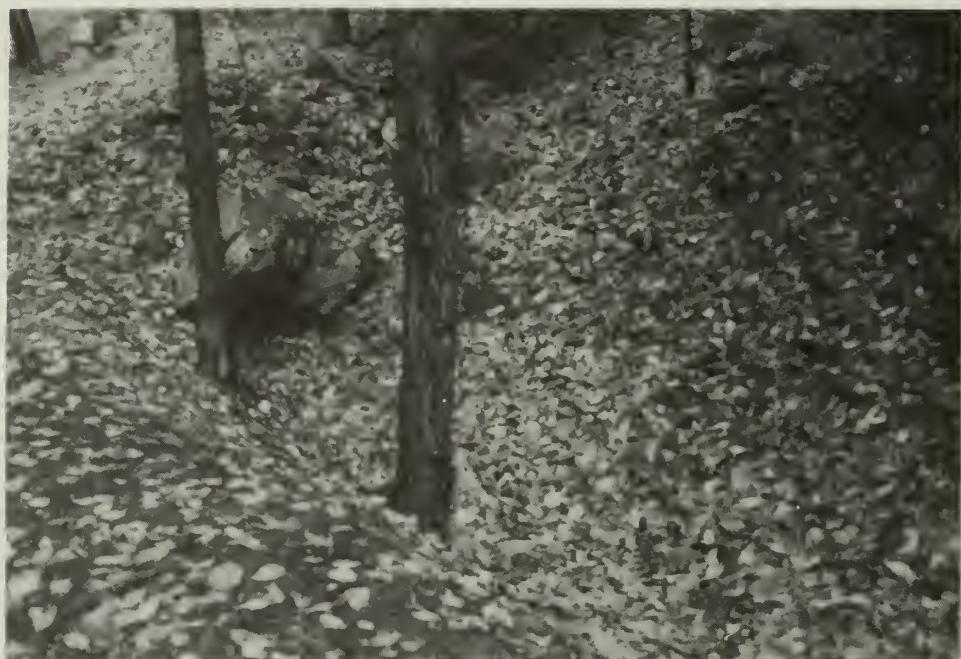
Figure 6B Photo 9
1908 spoil pile from tramway cut

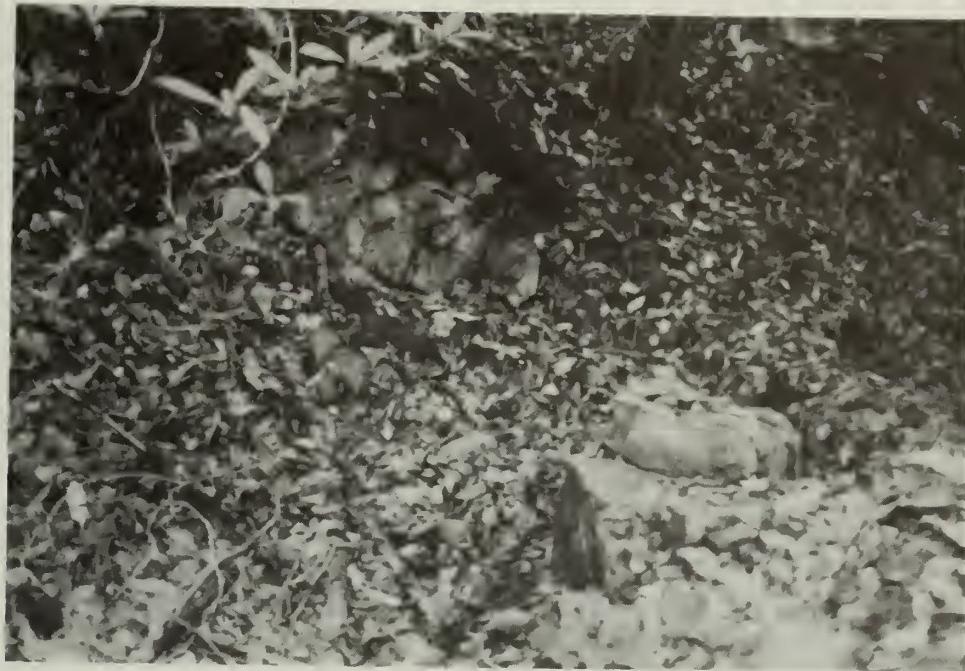
Figure 6B Photo 10
1750s prospect hole below adit number 2

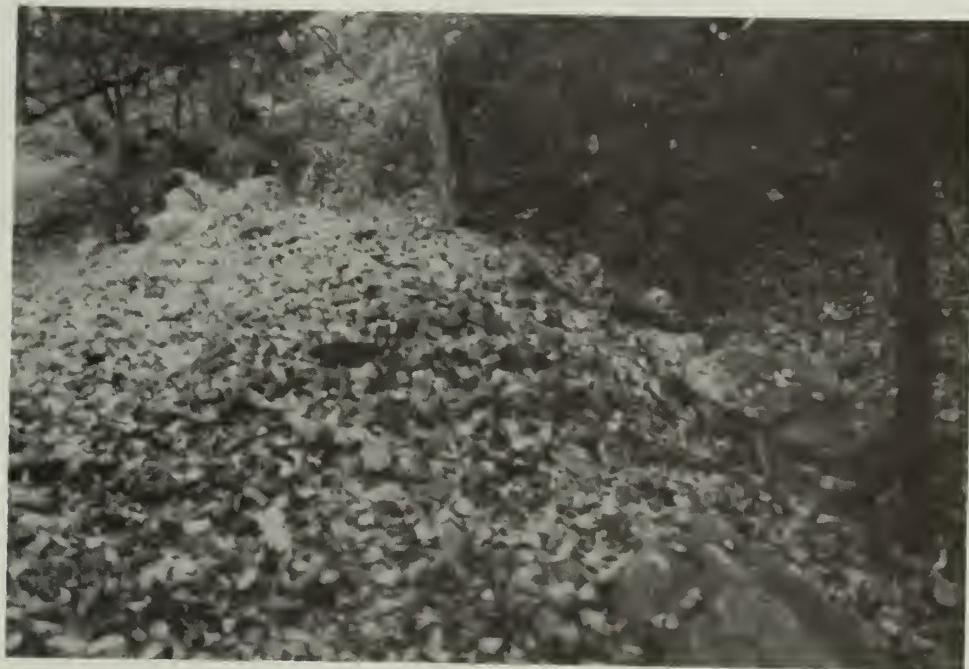
Figure 6B Photo 11
1750s workings below adit number 2

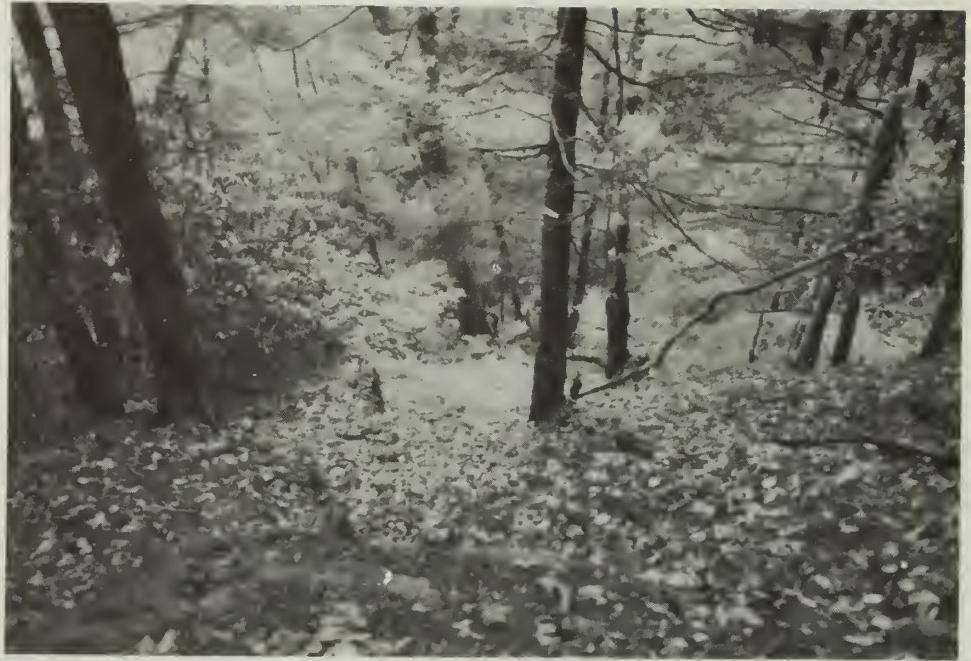
Figure 6B Photo 12
1750s tailings from workings below adit number 2

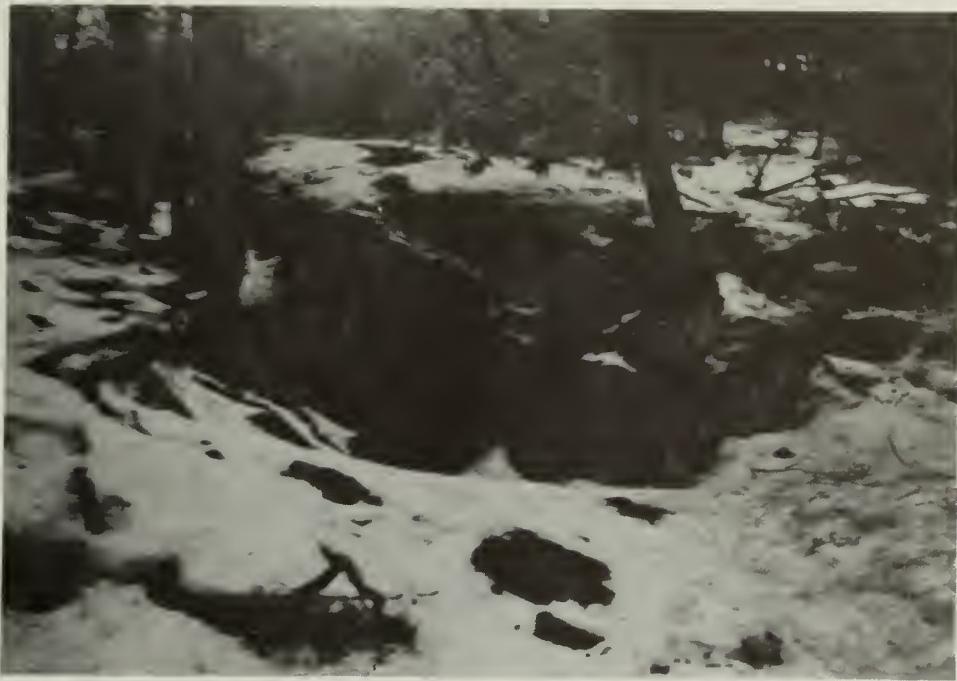
Figure 6B Photo 14
1750s workings below adit number 2

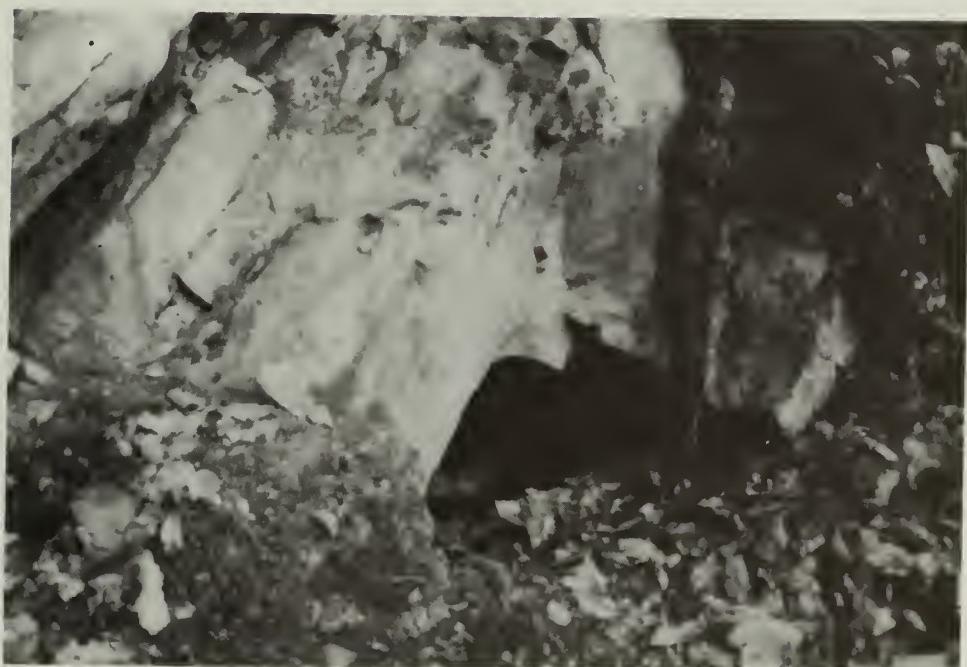
Figure 6B Photo 15
1750s adit number 2

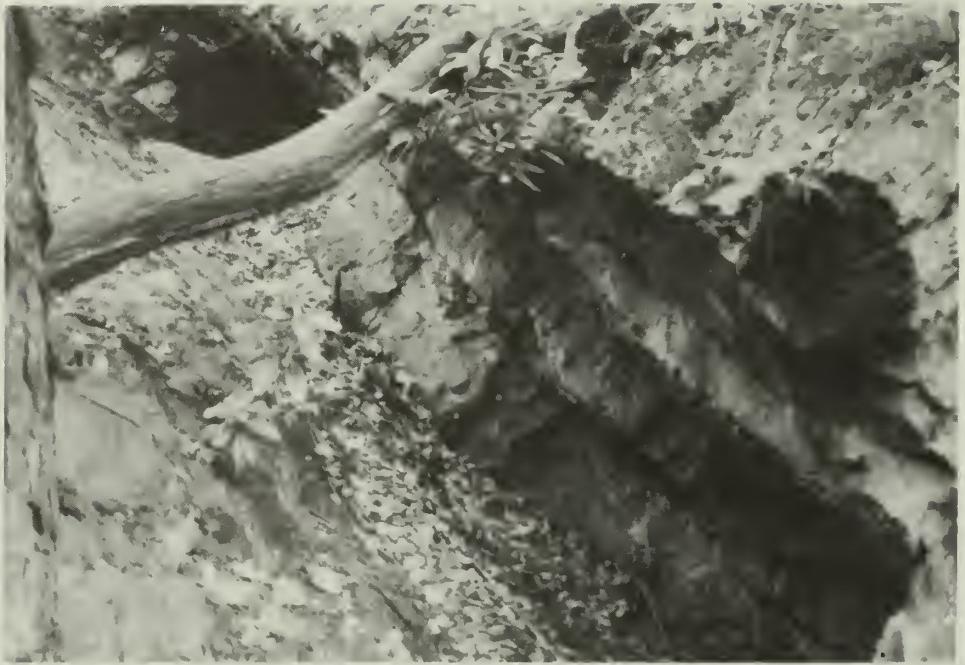
Figure 6B Photo 16
1750s workings along trench below incline number 3

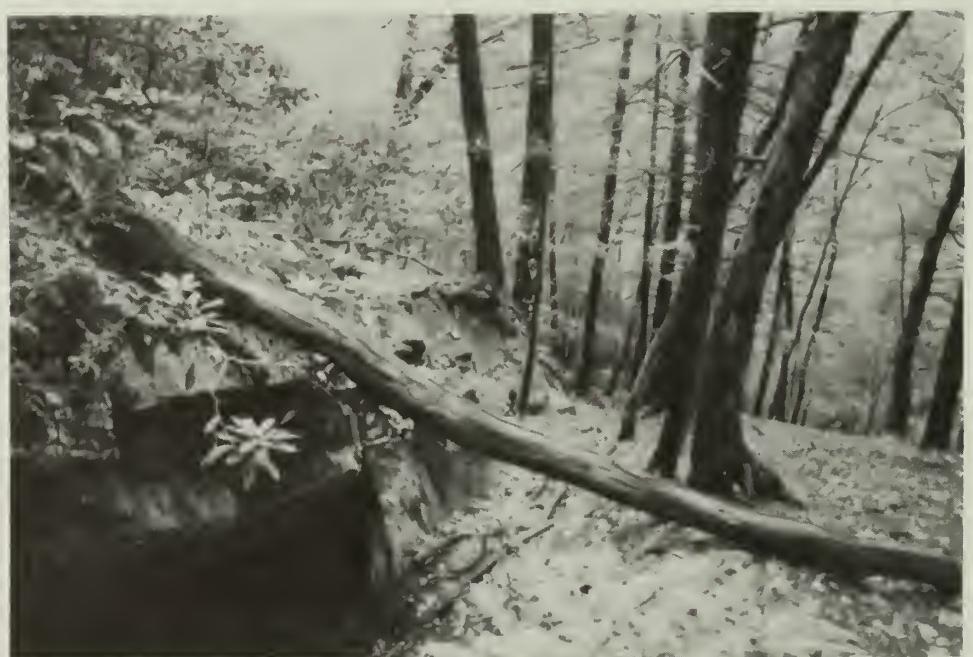
Figure 6B Photo 17
1750s incline 3 and 4 (number 3 in foreground)

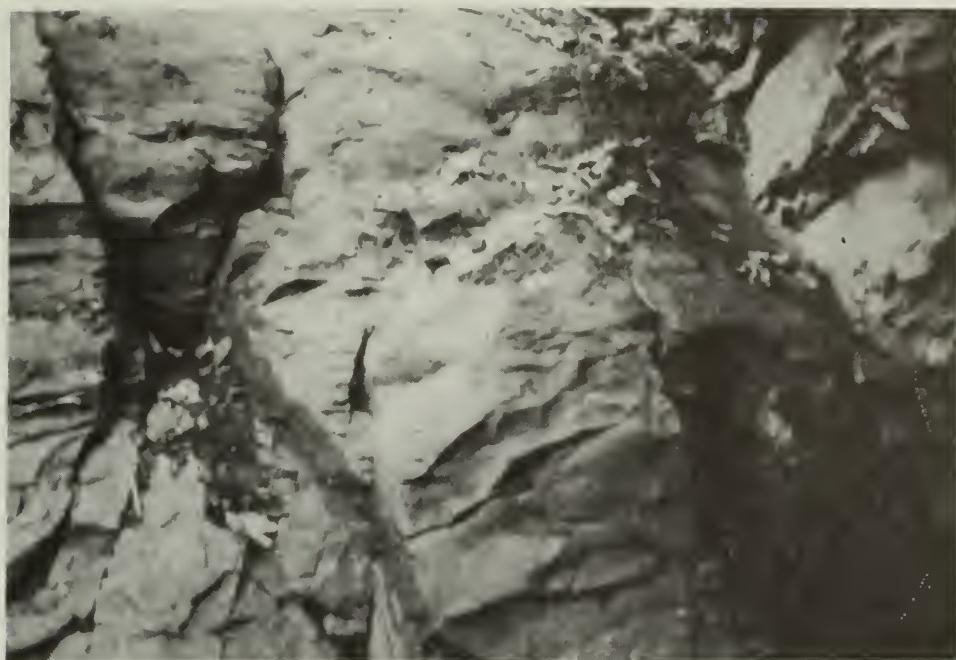
Figure 6B Photo 18
1750s workings looking down from incline 3 and 4

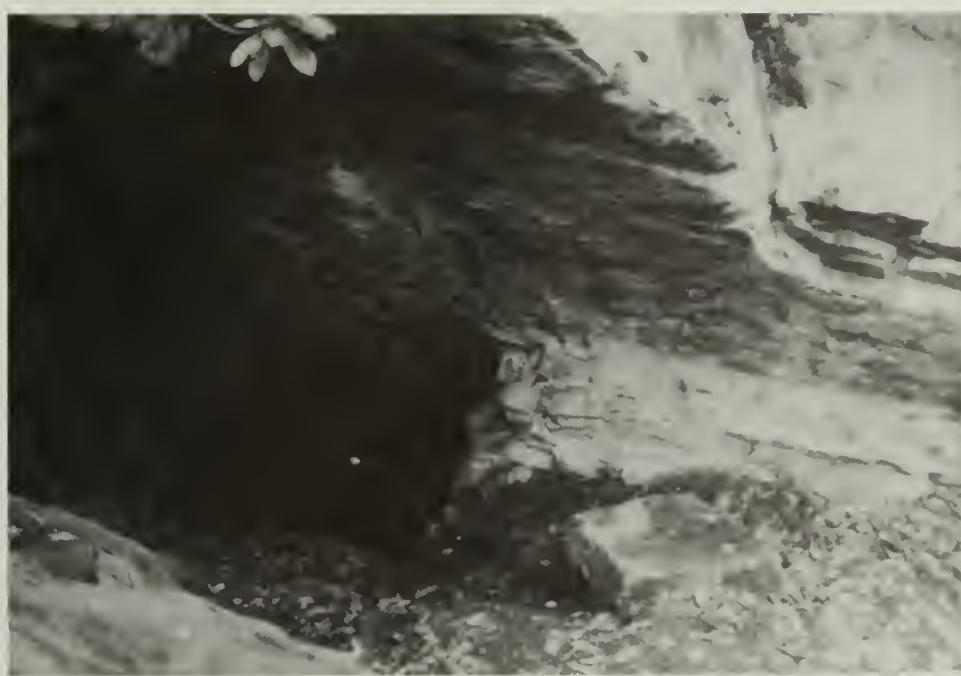
Figure 6B Photo 19
1750s pockets cut in rock above incline 4

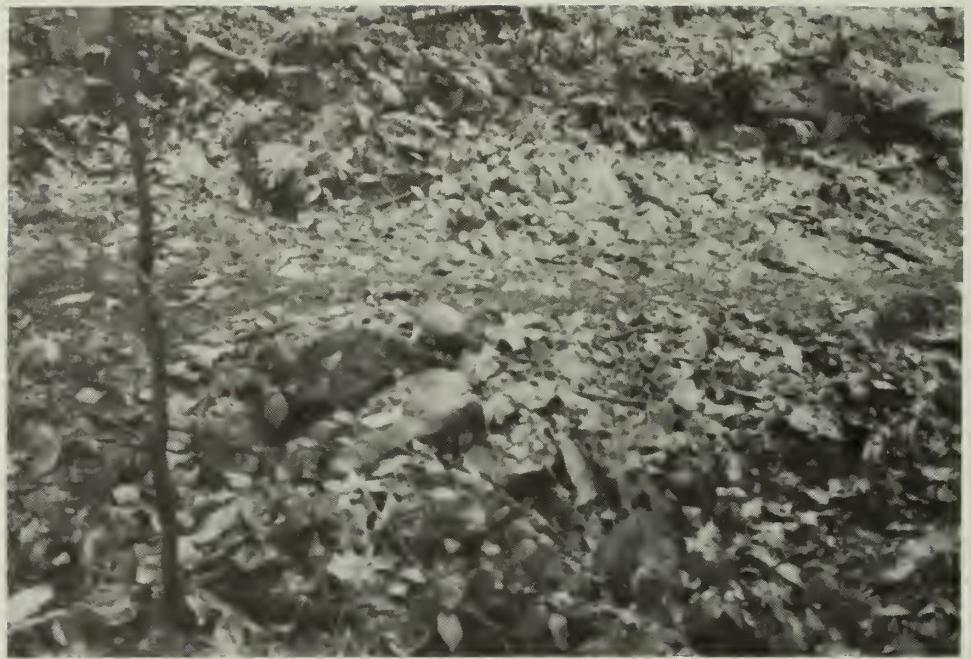
Figure 6B Photo 20
1750s incline number 4

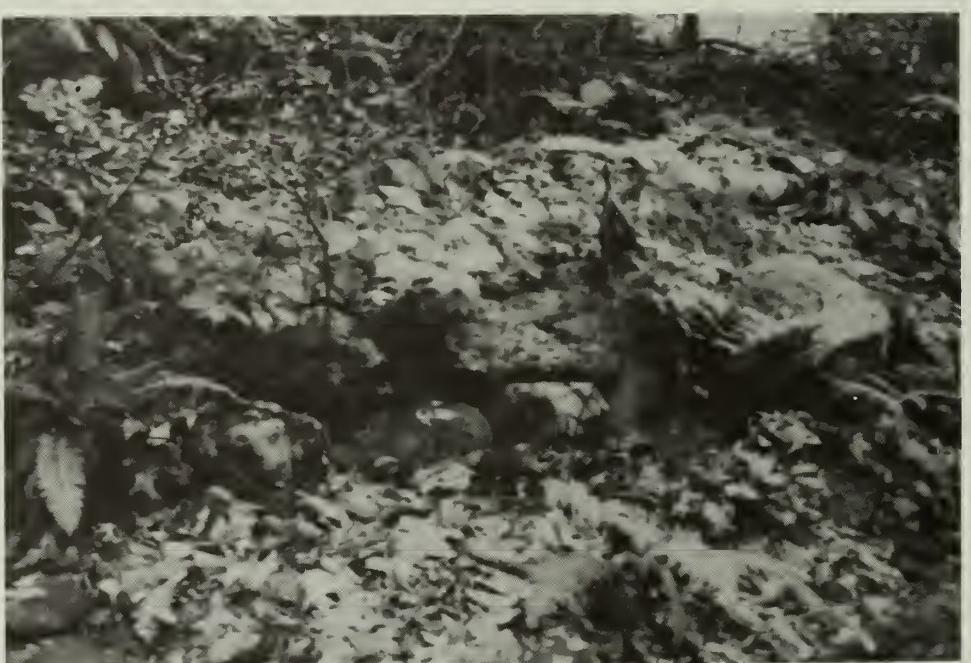
Figure 6B Photo 21
Unknown period possible 1750s stone retaining wall on upper side of mine brook road

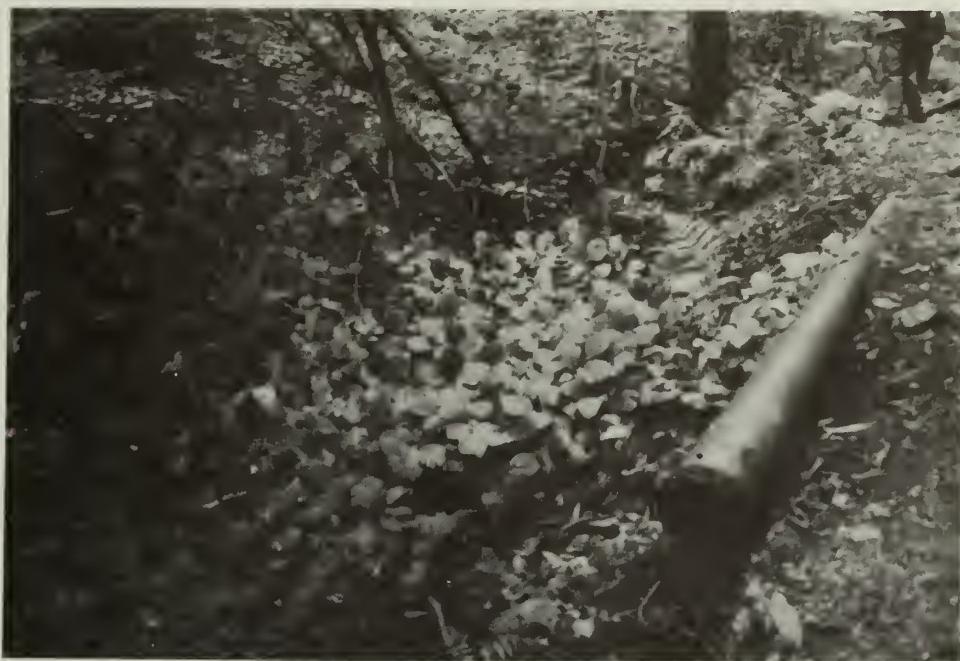
Figure 6B Photo 22
Unknown period possible 1750s stone retaining wall on lower side of mine brook road

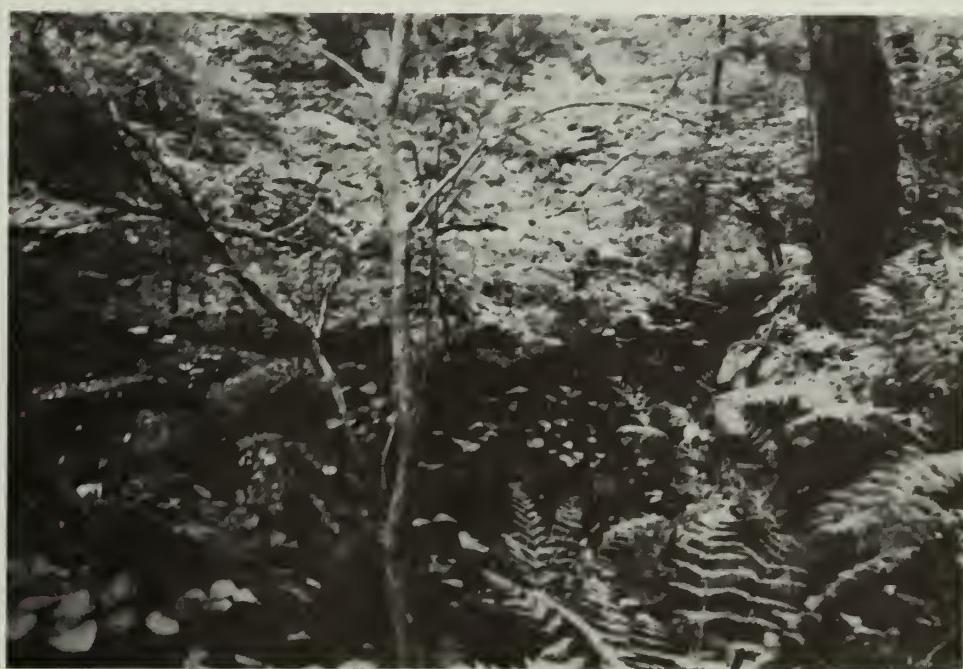
Figure 6B Photo 23
1904 6" water line from upper dam to mill

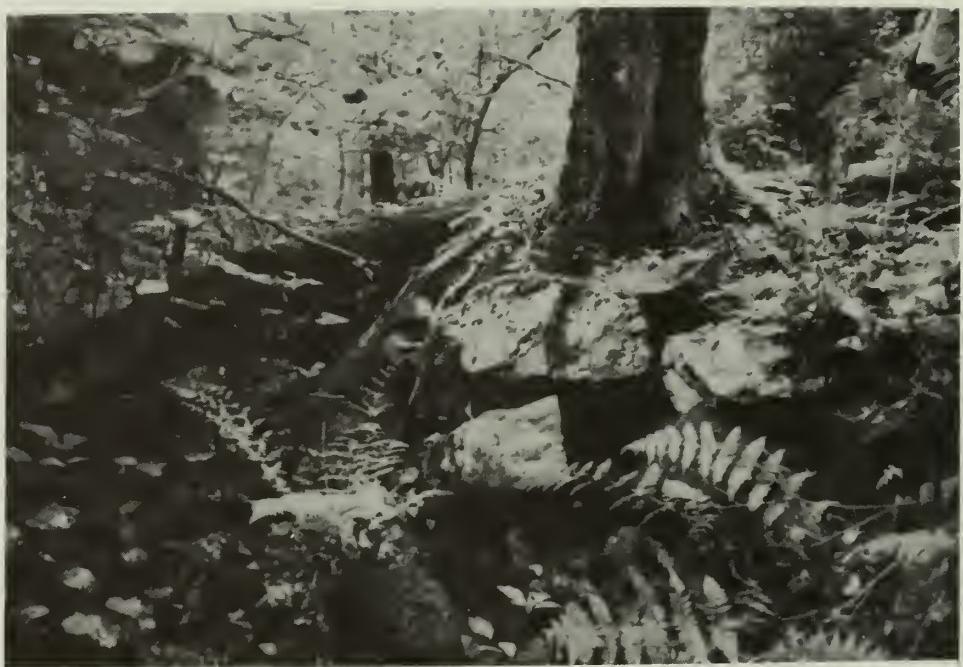
Figure 6B Photo 24
1750s colonial period remains of upper dam

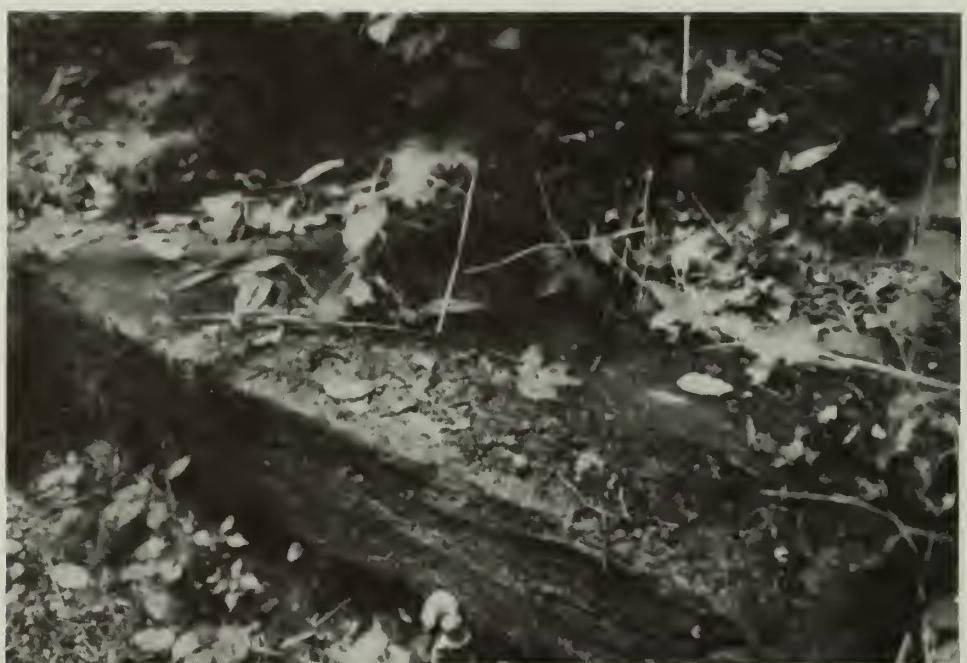
Figure 6B Photo 25
1750s colonial period remains of upper dam

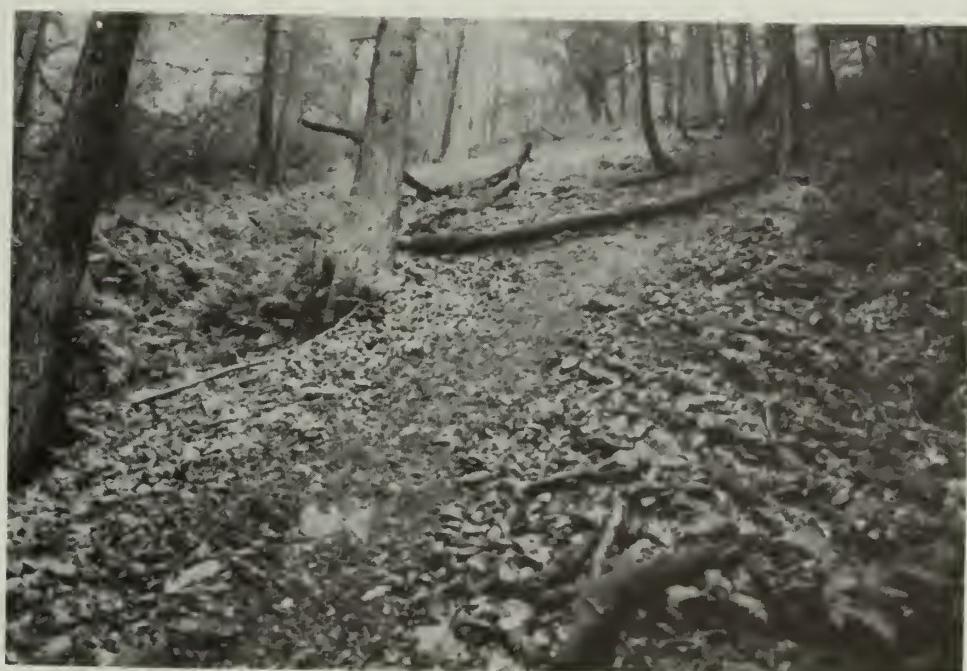
Figure 6B Photo 27
1750s period adit number 1

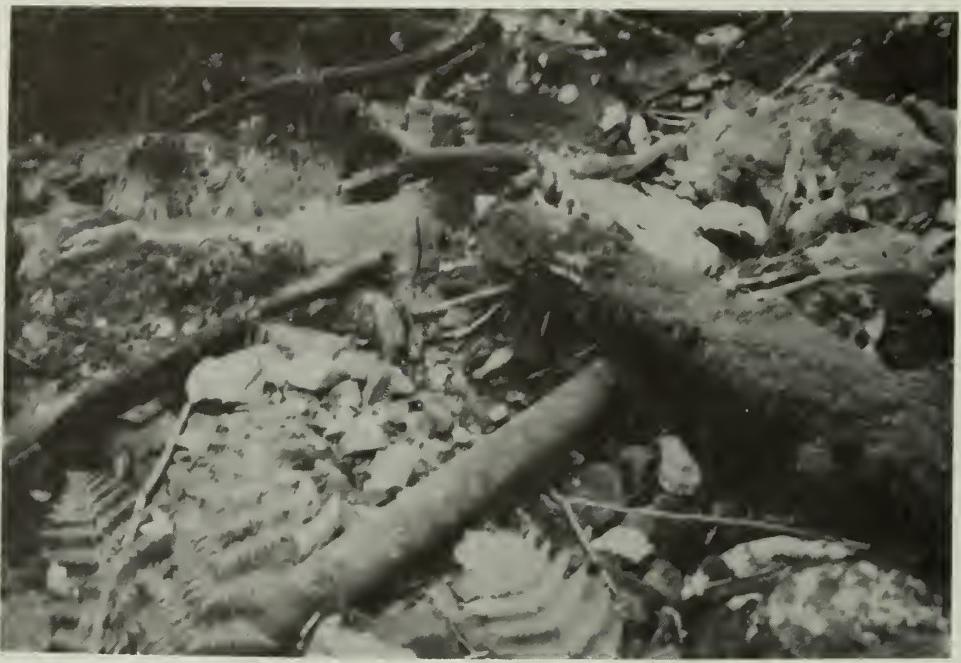
Figure 6B Photo 28
1750s period tailings from adit number 2 above

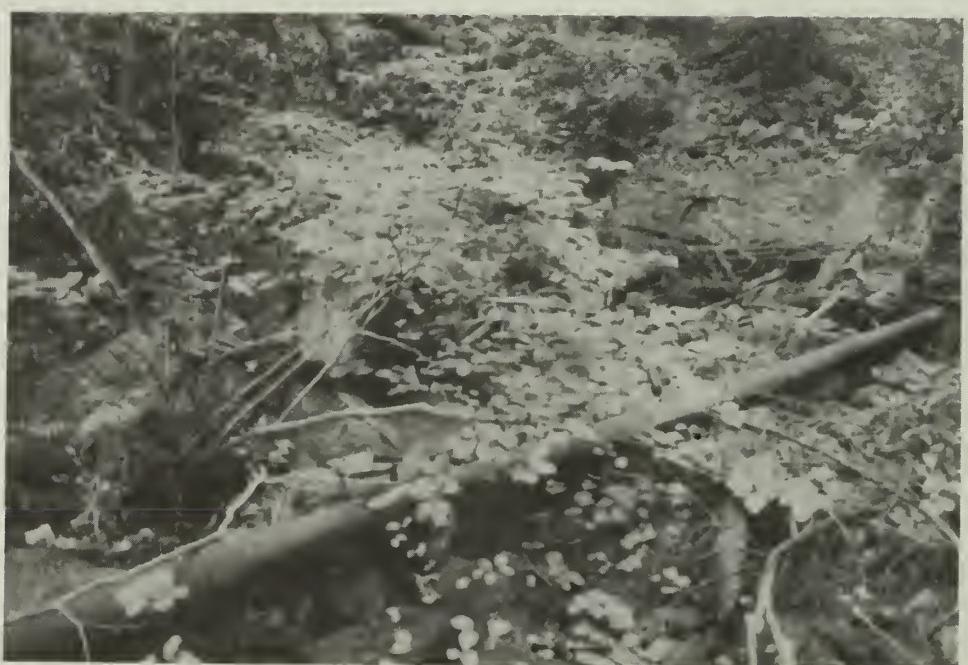
Figure 6B Photo 29
1904 " water line from upper dam to mill

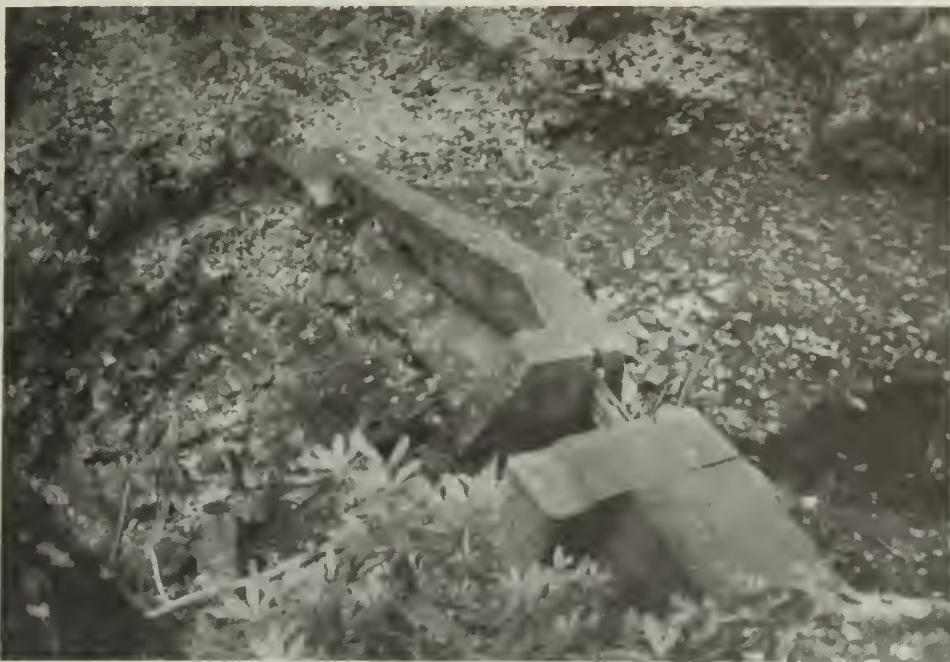
Figure 6B Photo 30
1904 6" water line from upper dam to mill

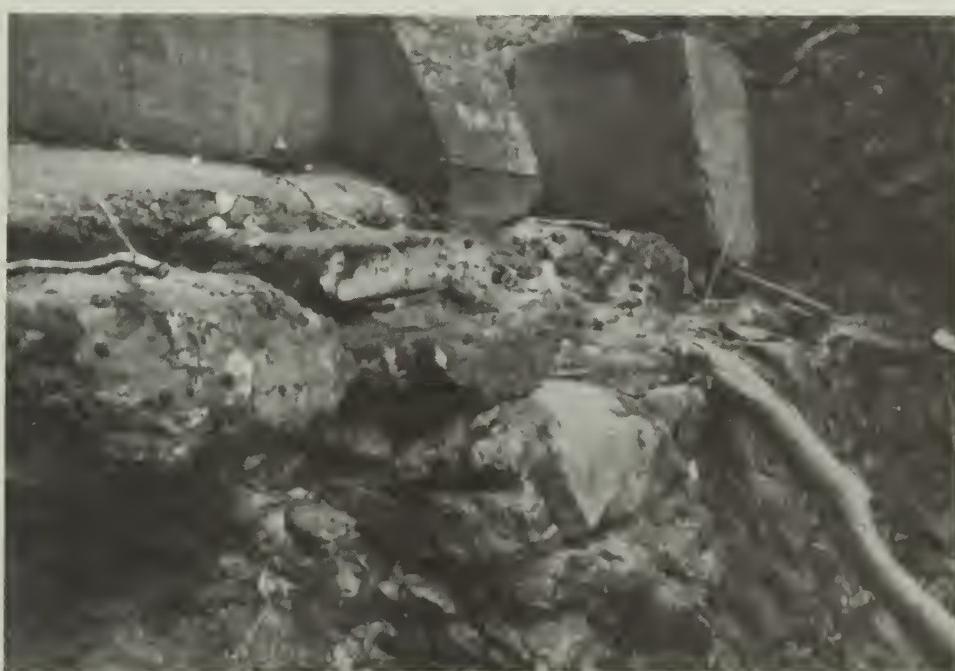
Figure 6B Photo 31
1904 and 1955 stone mining dam with later Boy Scout concrete dam
constructed over it

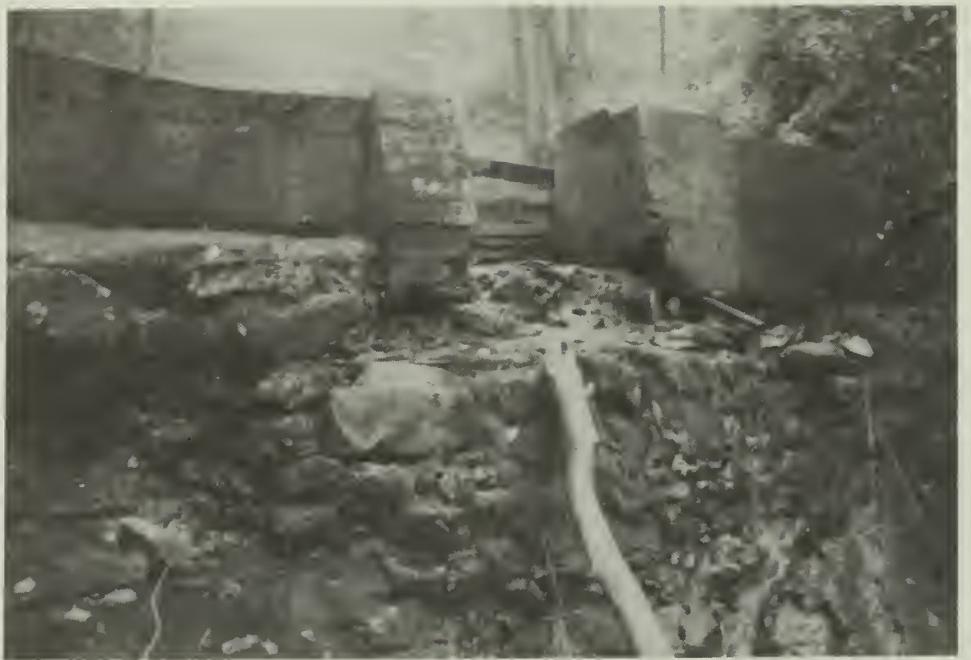
Figure 6B Photo 32
1904 and 1955 stone mining dam with later Boy Scout concrete dam
constructed over it

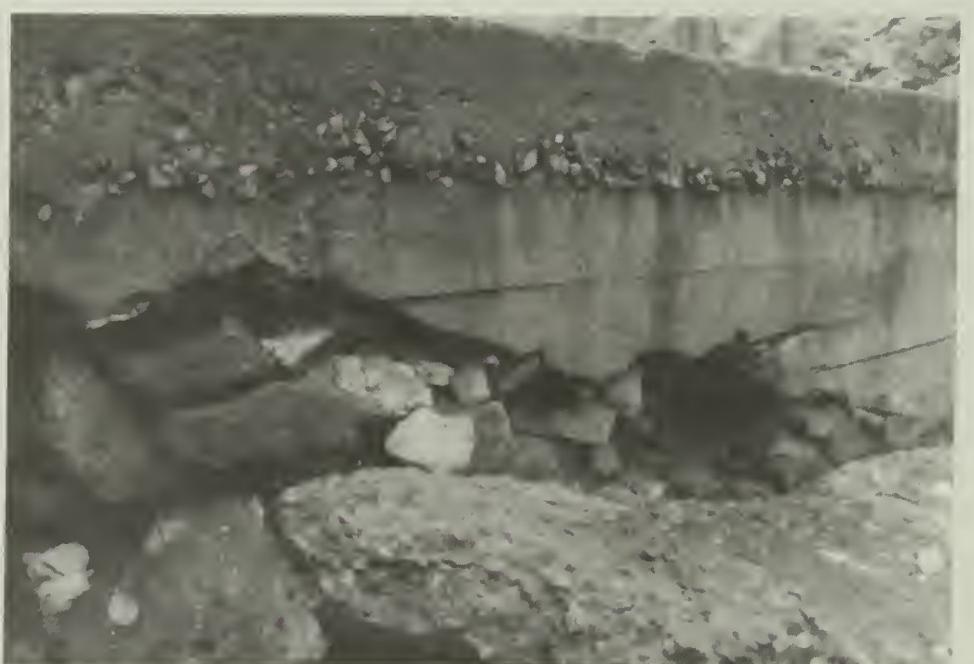
Figure 6B Photo 33
1904 and 1955 stone mining dam with later Boy Scout concrete dam constructed over it

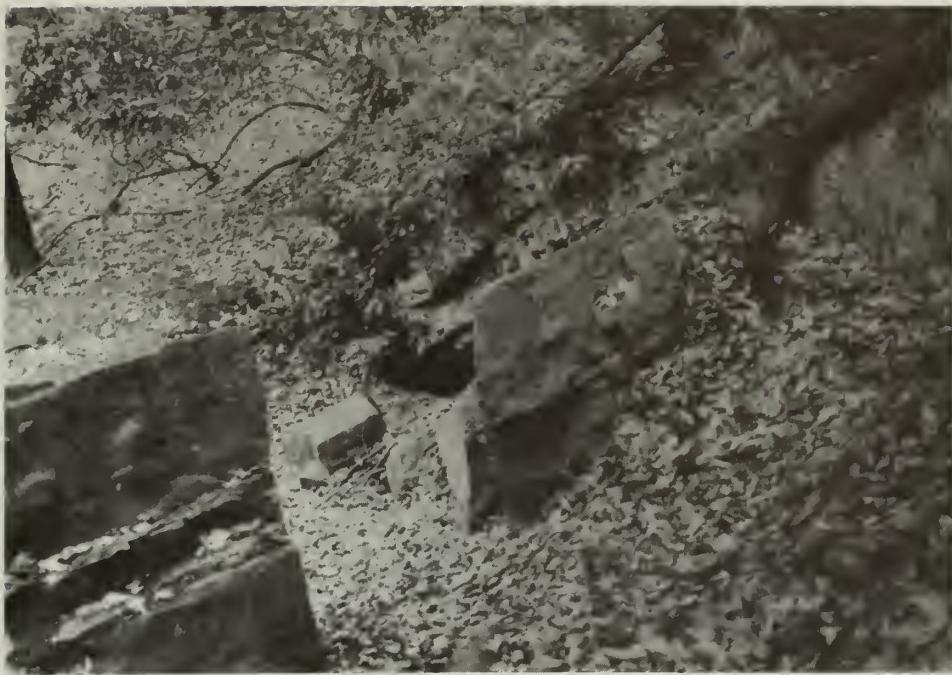
Figure 6B Photo 34
Detail of 1904 and 1955 stone mining dam and later Boy Scout construction

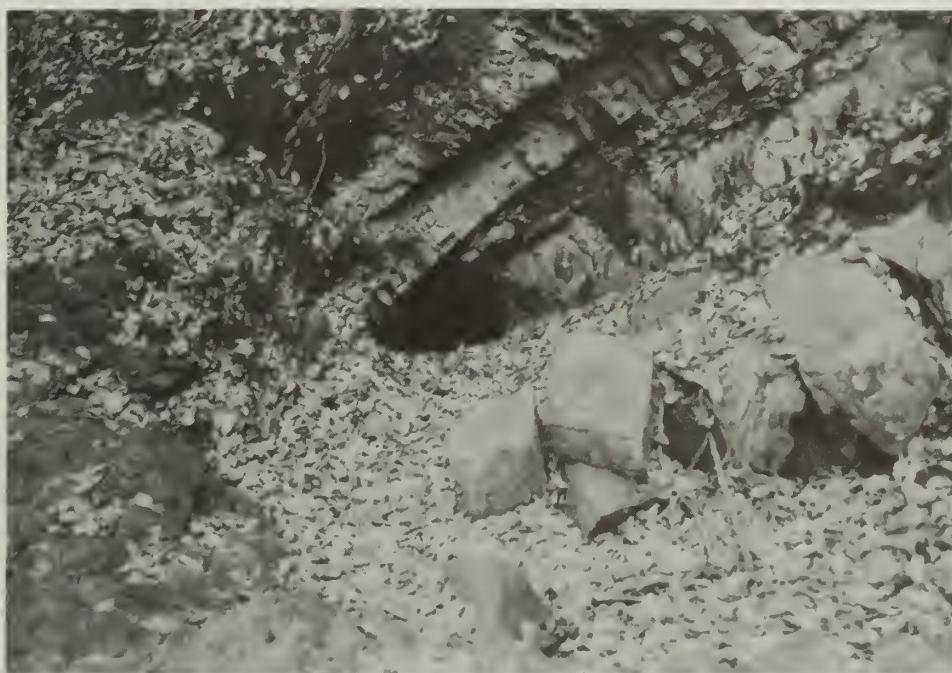
Figure 6B Photo 35
Colonial mine adit across from lower tunnel no. 1 above Minebrook.
